**MINE SAFETY AND HEALTH
ADMINISTRATION**

**PROFESSIONAL ENGINEERS IN
MINING MEETING**

TRENDS IN RECENT FATALITIES AND COAL'S TRAINING ASSISTANCE INITIATIVE (UPDATE)

**Robert A. Simms
District Manager
CMS&H, District 10**

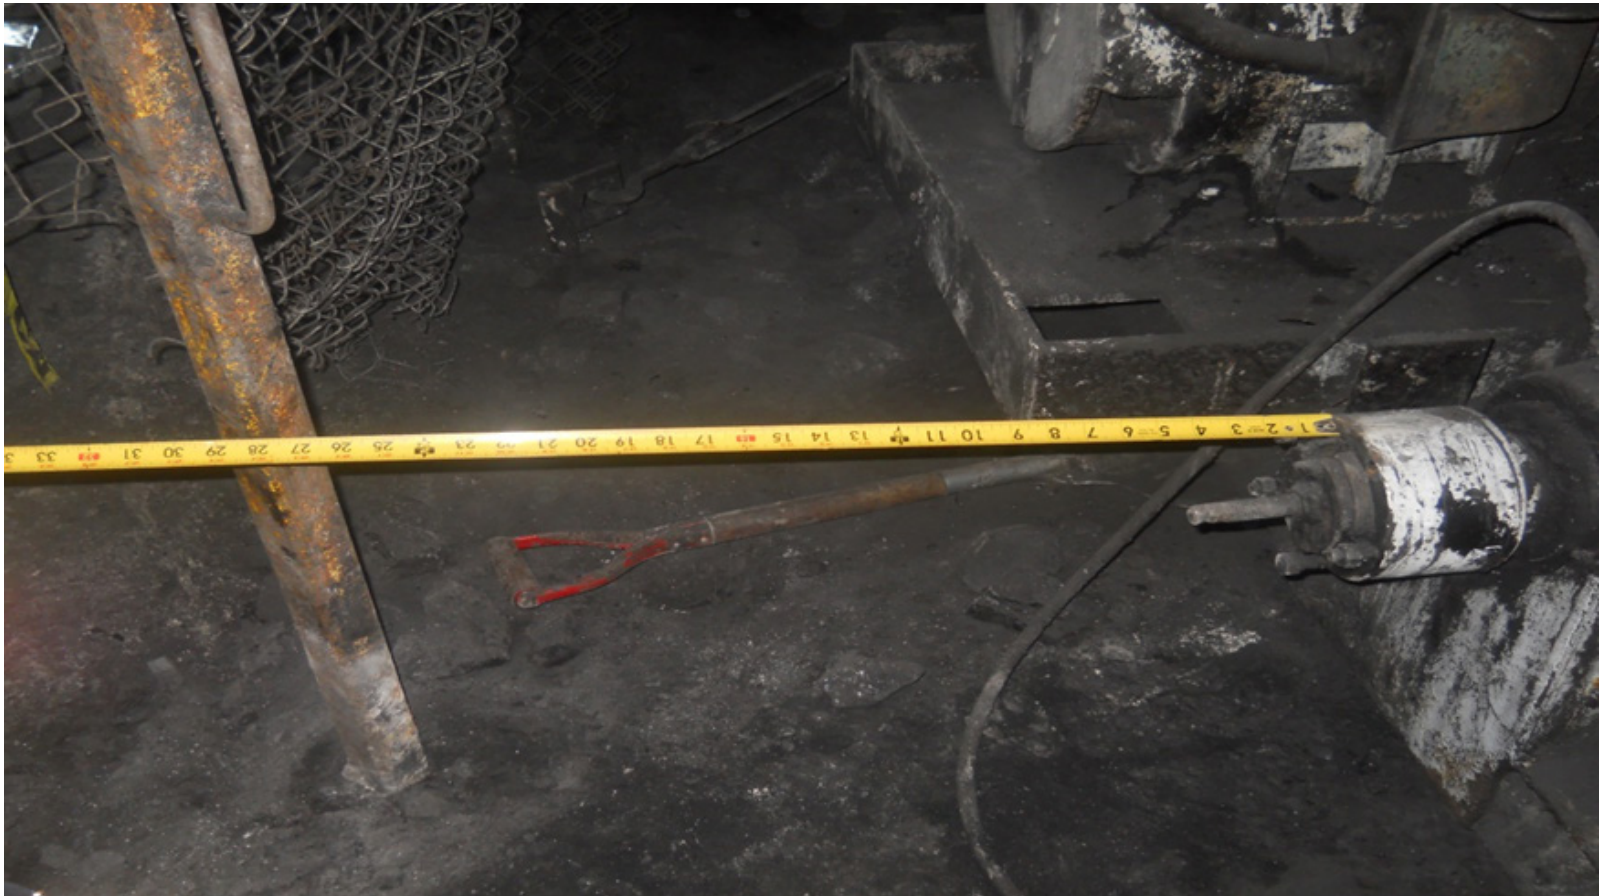
On Thursday, January 26, 2017, a 42-year-old miner, with less than 1 year of experience at the mine and less than 1 year of experience at the job he was performing, was fatally injured when he contacted a moving drive roller for the section belt. The victim was positioned between the guard and the conveyor belt drive when he came in contact with the shaft of the belt drive roller.

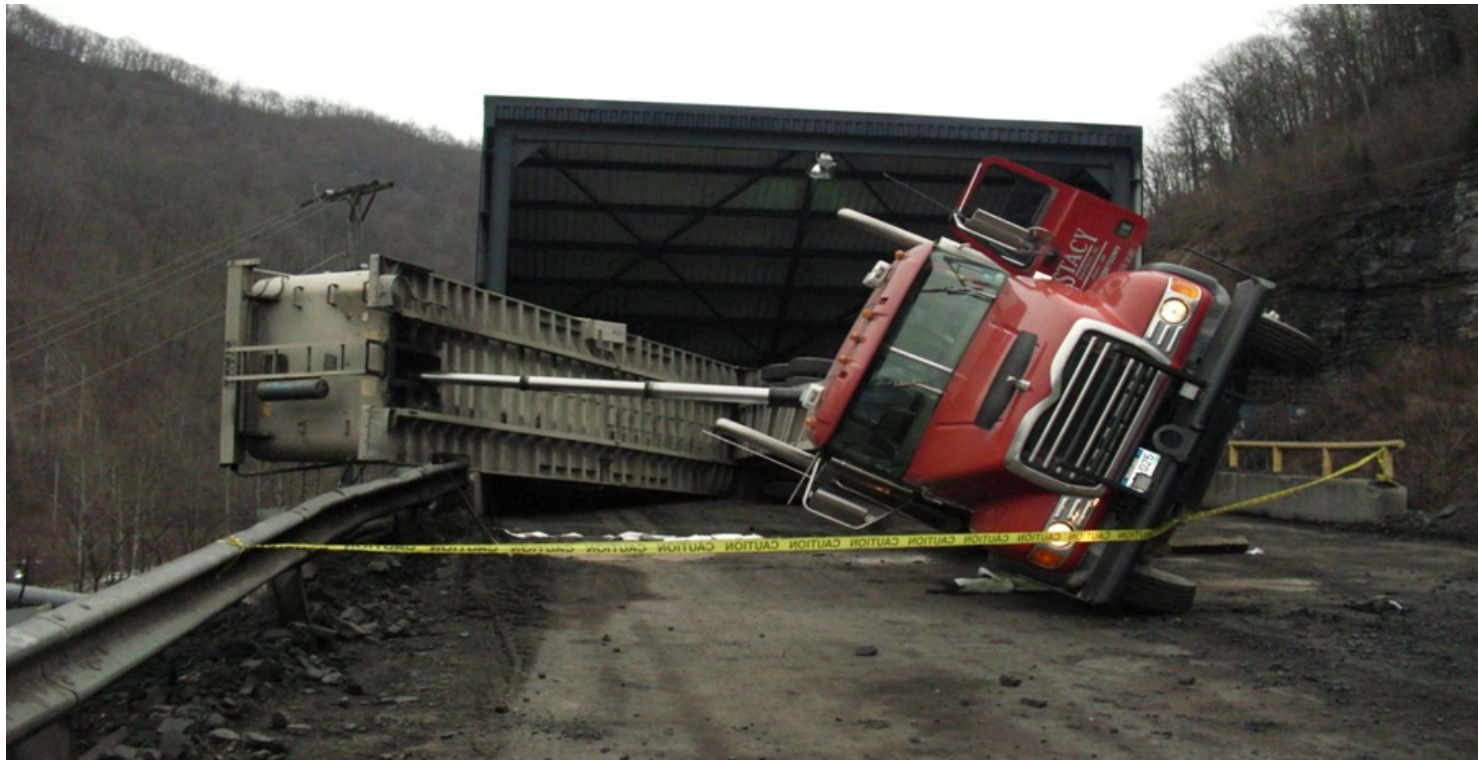
On February 3, 2017, a 54-year-old truck driver, with less than 1 year of experience at the mine, received hip and leg fractures when he jumped from the cab of his truck as it was overturning. The victim had positioned the truck on the dump pad and began raising the bed. Material in the bed was frozen or compacted and created an uneven load. As the bed reached full extension, the truck fell over. Due to complications associated with his injuries, the victim passed away 7 days later.

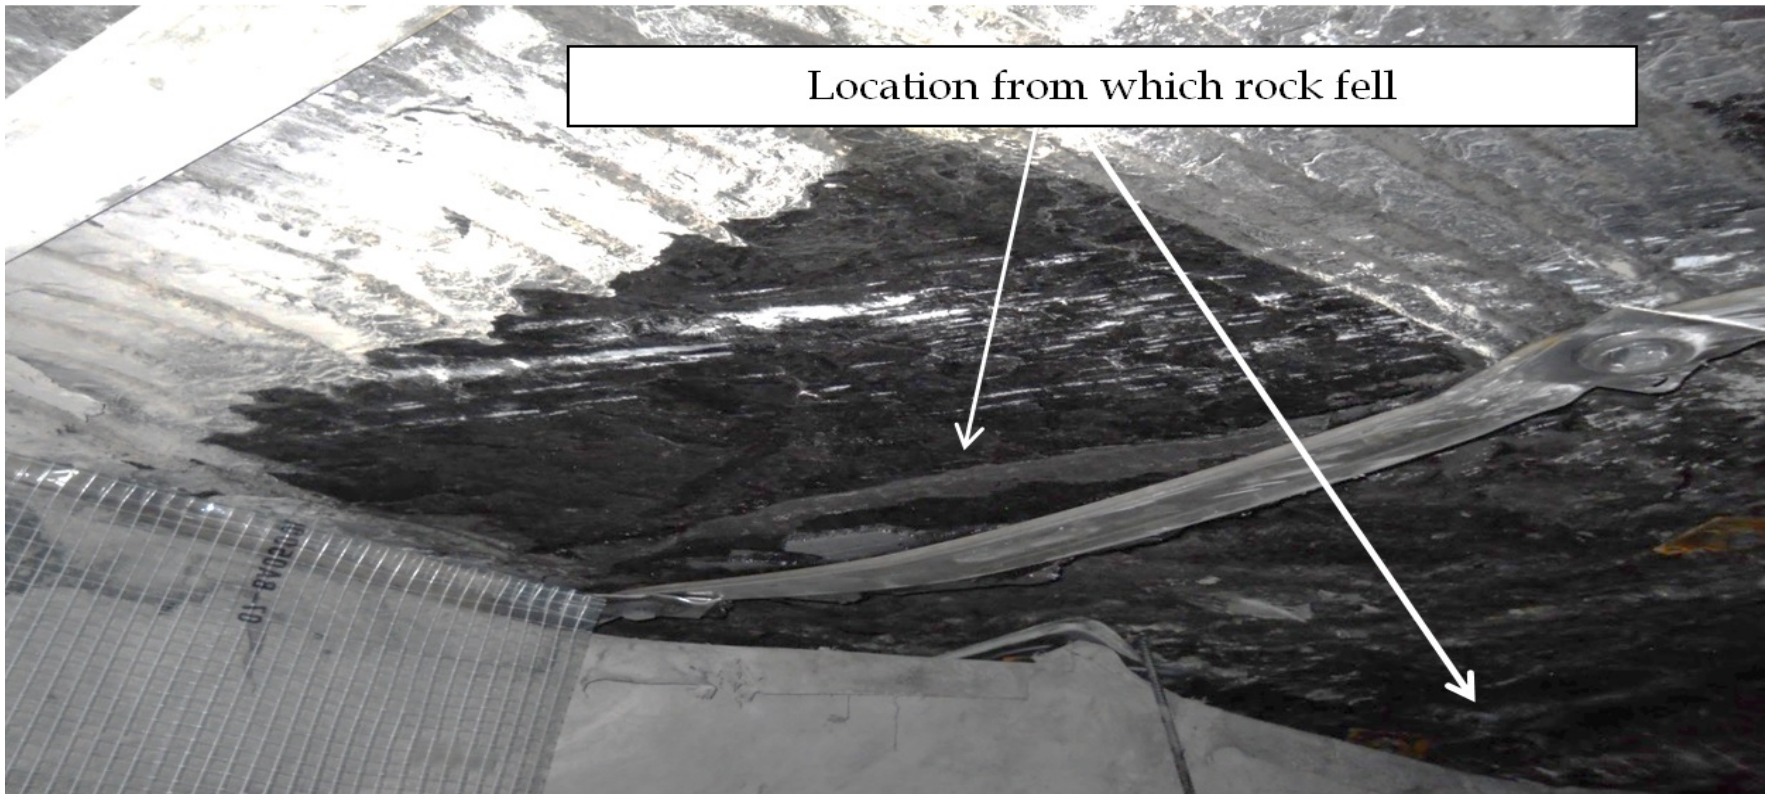
On February 23, 2017, a 62-year-old section foreman, with less than 1 year of experience at the mine and less than 1 year of experience at the job he was performing, was seriously injured by falling roof rock in the No. 3 entry of the active working section. The rock fell from between roof bolts and was approximately 3 feet by 2 feet by 3 to 4 inches thick. First-aid was administered and the injured miner was transported to a medical center. Due to medical complications from the injuries he sustained, the victim died on April 6, 2017.

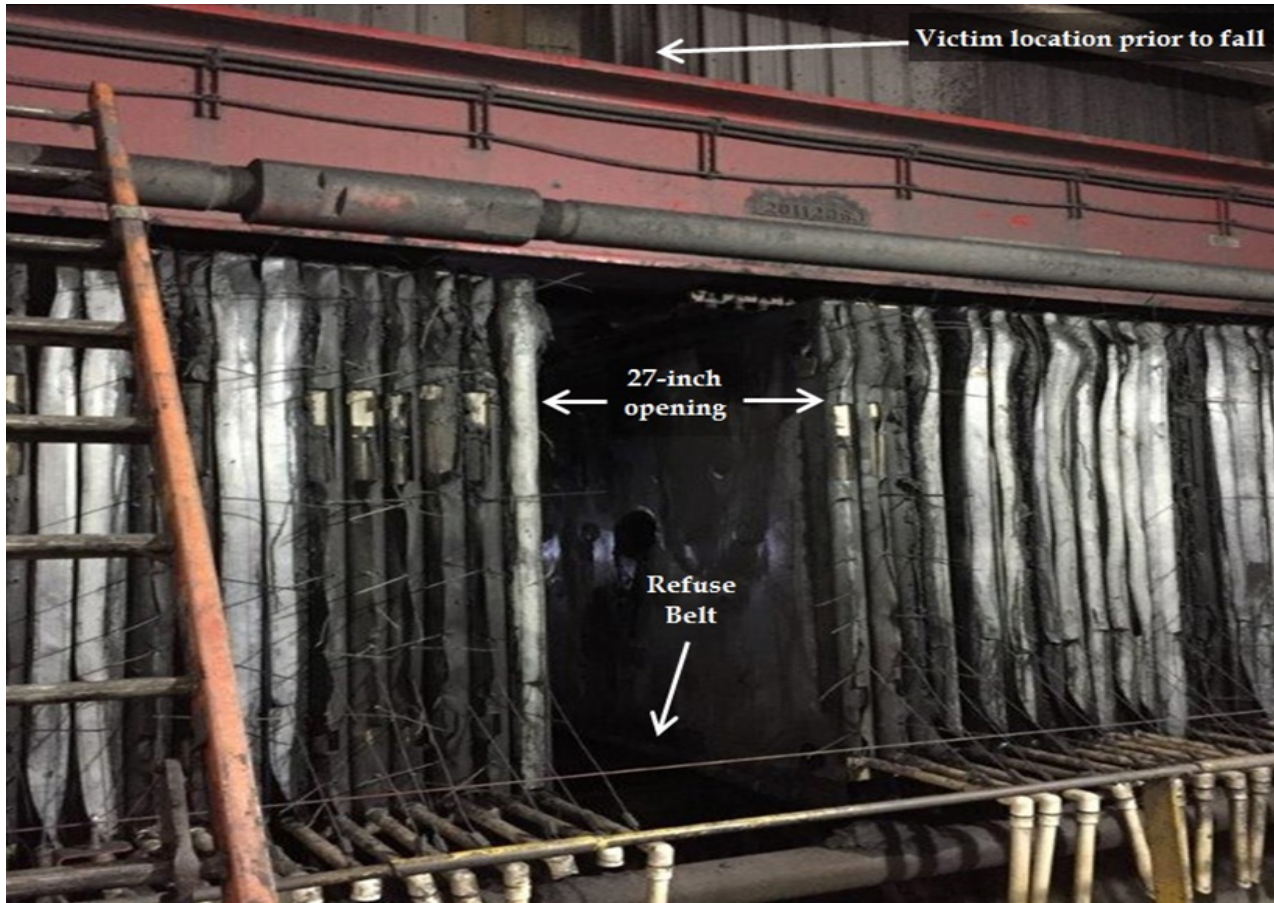
On February 27, 2017, a 43-year-old plant attendant, with less than 1 year of experience at the mine and less than 1 year of experience at the job he was performing, was fatally injured when he fell through a 27-inch opening in a plate press. The victim had climbed a ladder to repair a damaged plate when he fell about 19 feet onto a moving refuse belt.

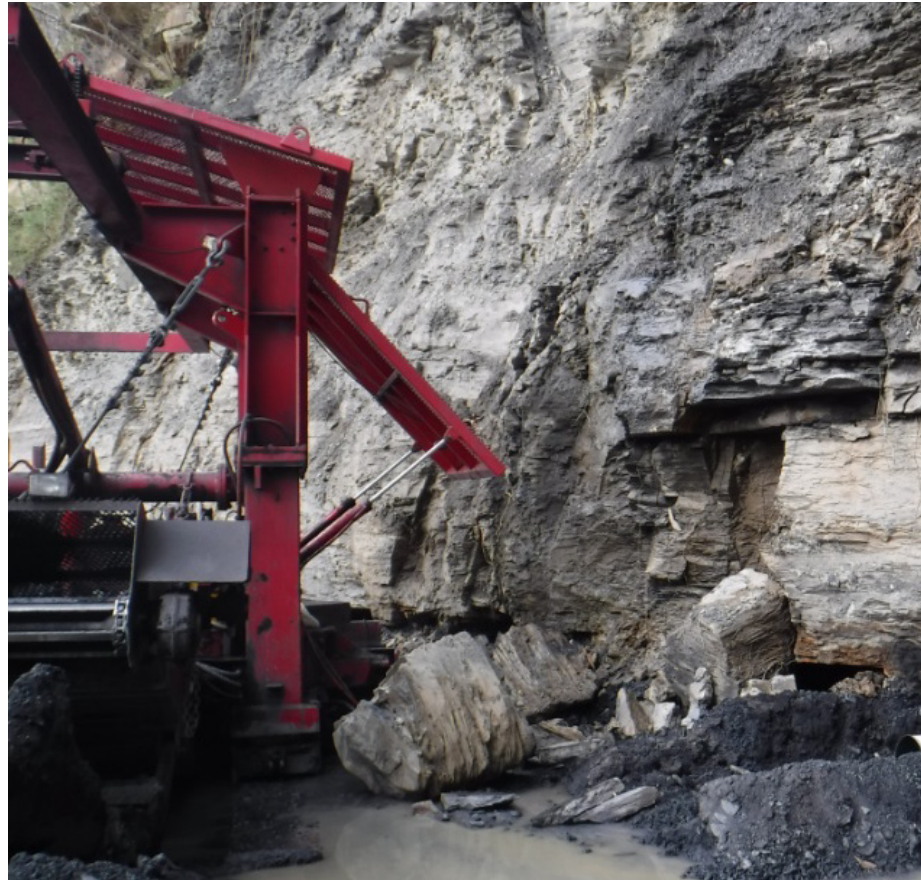
On March 30, 2017, at 2:09 am, a 33-year-old miner (auger operator/foreman), with less than 1 year of experience at the mine and 1 year of experience at the job he was performing, was fatally injured at a surface auger mine. The miner was struck by a rock that fell from the bottom section of the highwall while changing worn cutter-head bits located at the front of the auger machine. The rock was approximately 4 feet by 5 feet by 30 inches in size.

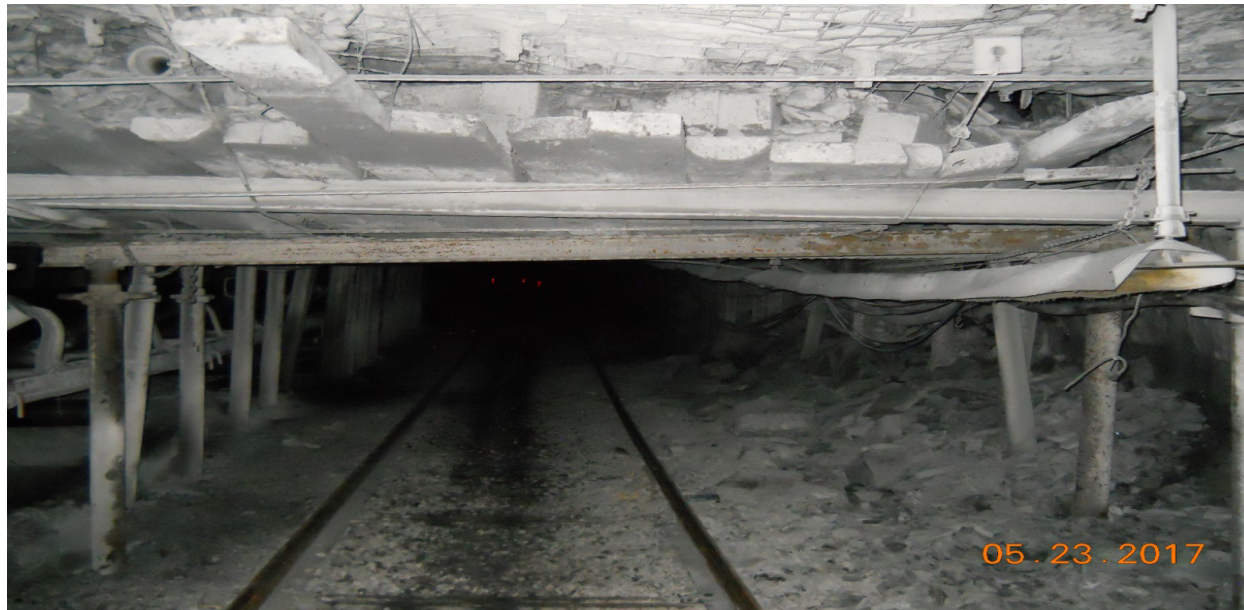
On Thursday, May 18, 2017, an outby utility miner, with less than 1 year of experience at the mine and less than 1 year of experience at the job he was performing, received fatal injuries when his head hit the mine roof and/or roof support. He and another miner were travelling in a trolley-powered supply locomotive when the accident occurred. While the locomotive was still in motion, the trolley pole came off the trolley wire. The victim grabbed the trolley pole to place it back on the trolley wire. In this slightly elevated position, the victim hit his head on the mine roof and/or roof support and was fatally injured.

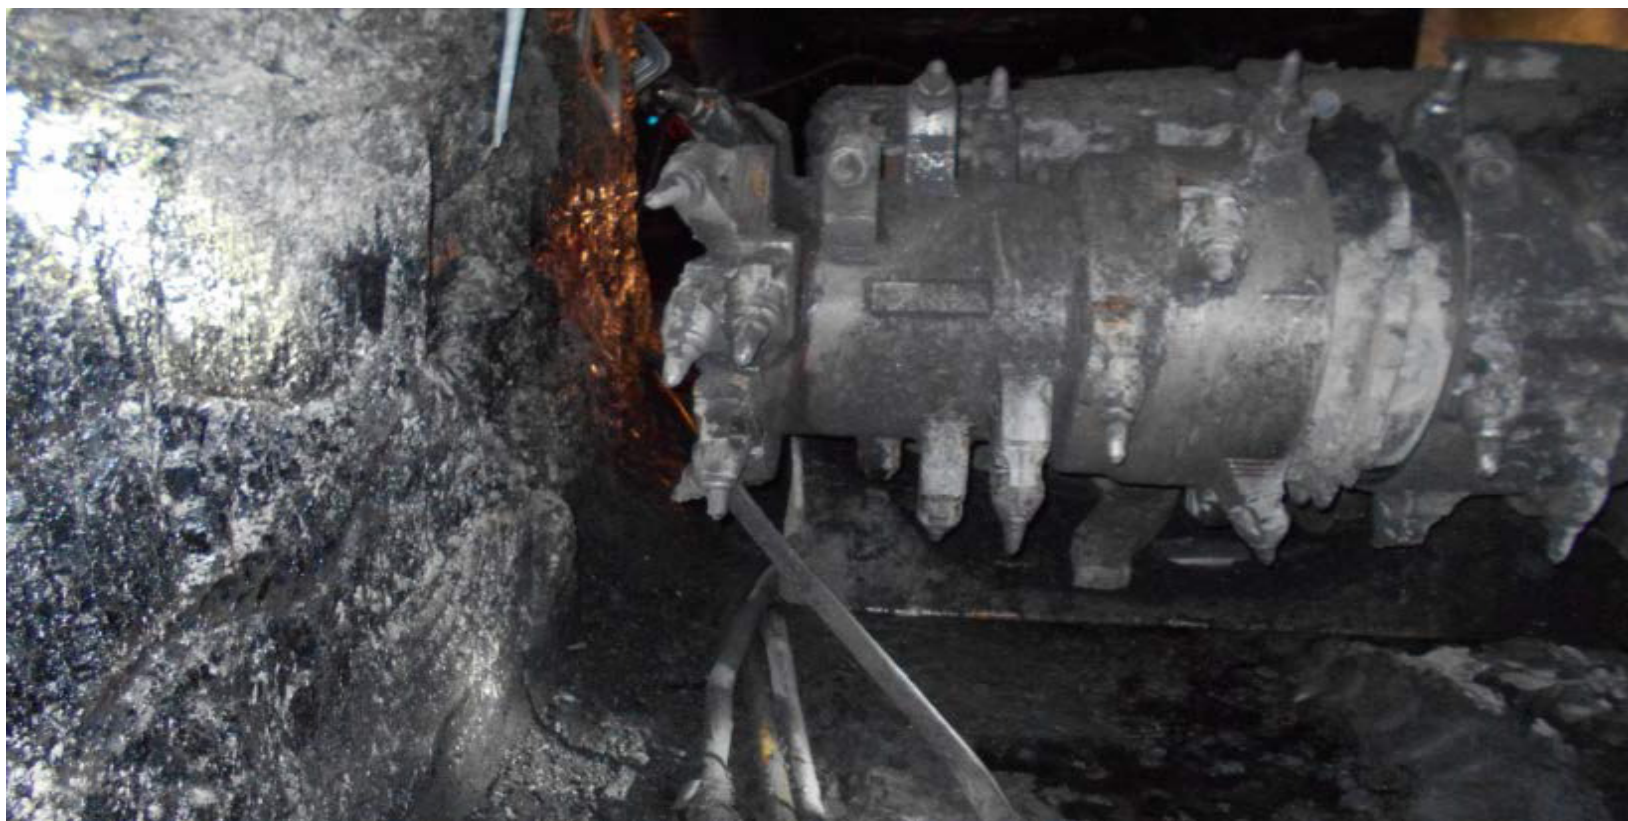
On Tuesday, June 13, 2017, a 32-year-old continuous mining machine operator, **with less than 1 year of experience at the mine and less than 1 year of experience at the job he was performing**, was fatally injured when he was pinned between the cutter head of a remote controlled continuous mining machine and the coal rib. The victim was backing the continuous mining machine from the **working face when the accident occurred.**

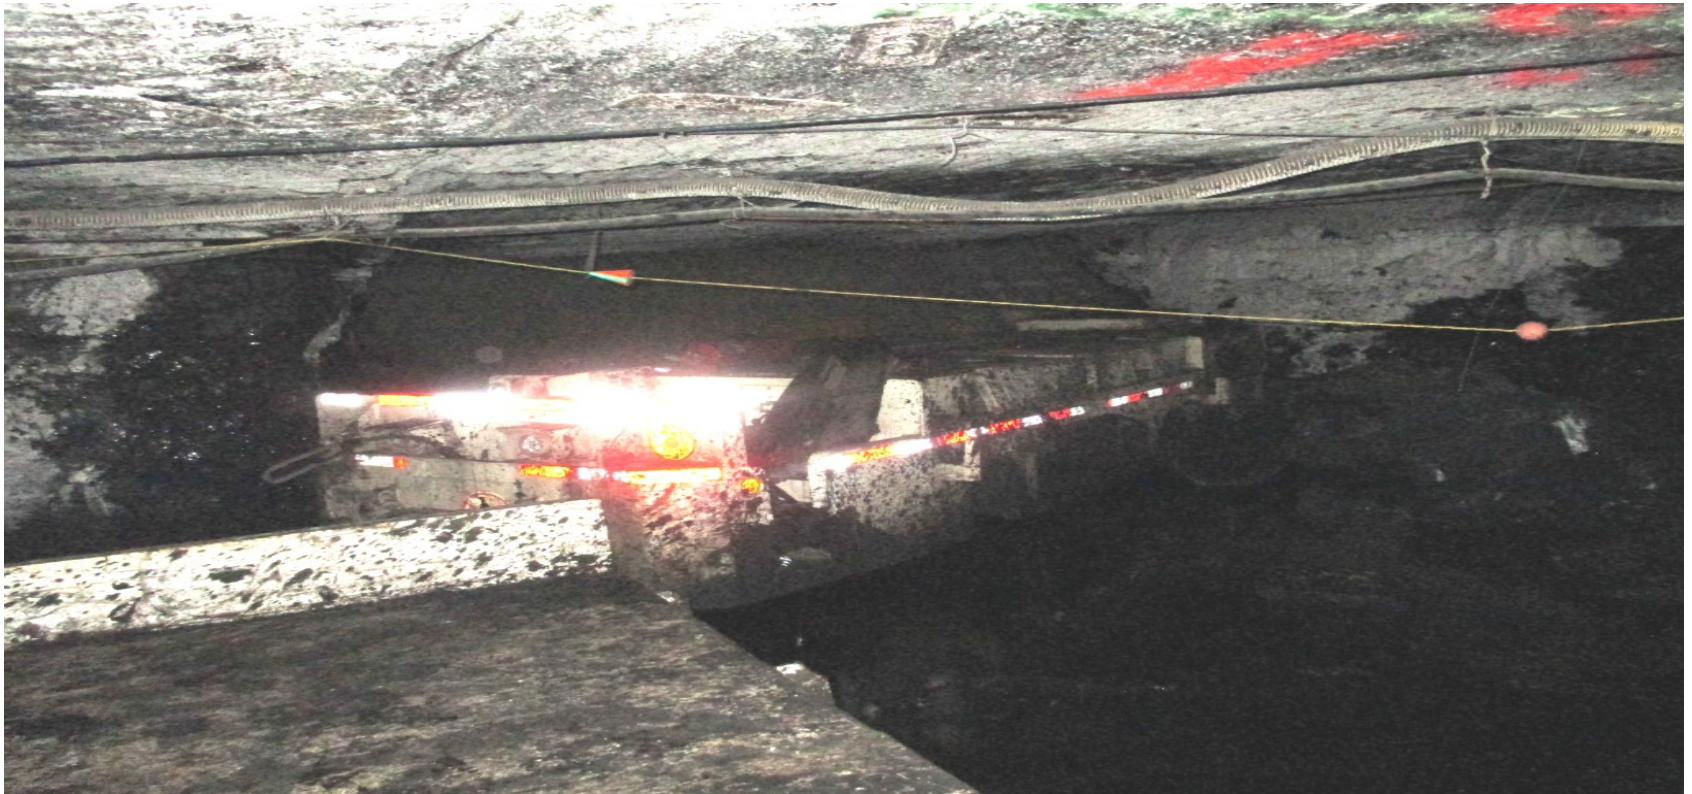
On June 19, 2017, a 32-year-old preshift examiner, with less than 1 year of experience at the mine and less than 1 year of experience at the job he was performing, was fatally injured when he was thrown or jumped from a moving locomotive. Two locomotives (front and rear) were being used to transport three supply cars into the mine. The examiner was riding in the passenger seat of the front locomotive when the operators lost control on a grade and the front locomotive and the first two supply cars derailed.

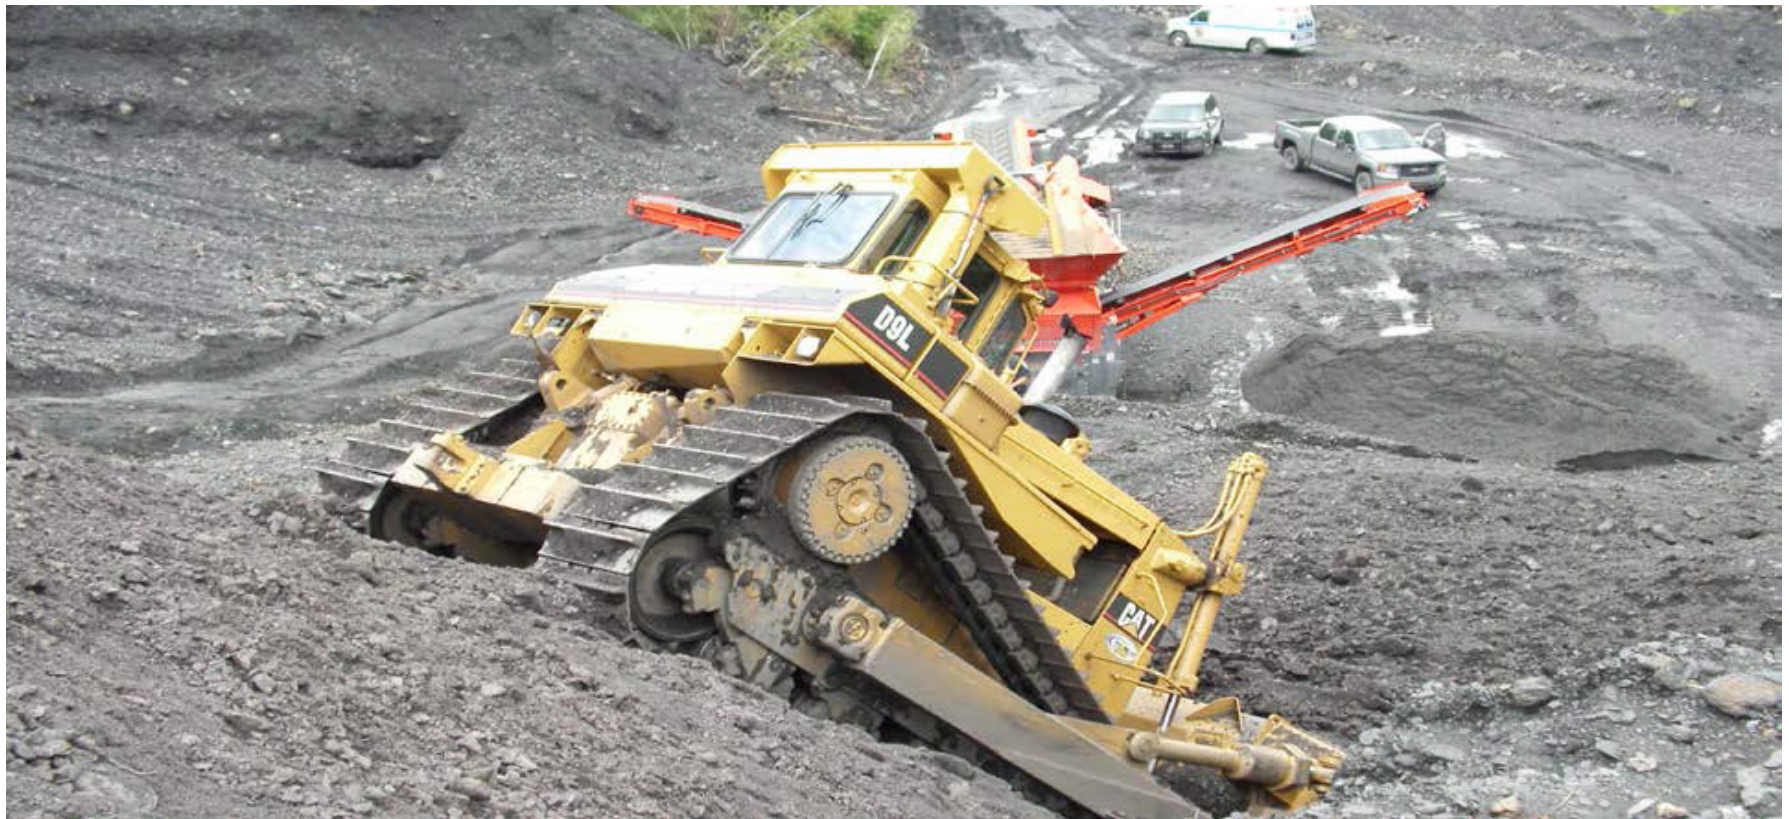
On July 25, 2017, A 28-year-old bulldozer operator, **with over 7 years of experience at the job and less than two weeks of experience at the mine**, was fatally injured at a surface facility. The victim was operating a bulldozer, pushing material off of a refuse bank before the accident occurred. He was found lying in the bulldozer's push path at the top of an incline near the edge of the refuse bank. The bulldozer had run over the victim and continued over the edge of the incline, coming to rest at the bottom of the embankment.
