DIVISION OF MINE SAFETY

KENTUCKY FATALITIES BY YEAR

EMERGENCY AWARENESS BULLETIN

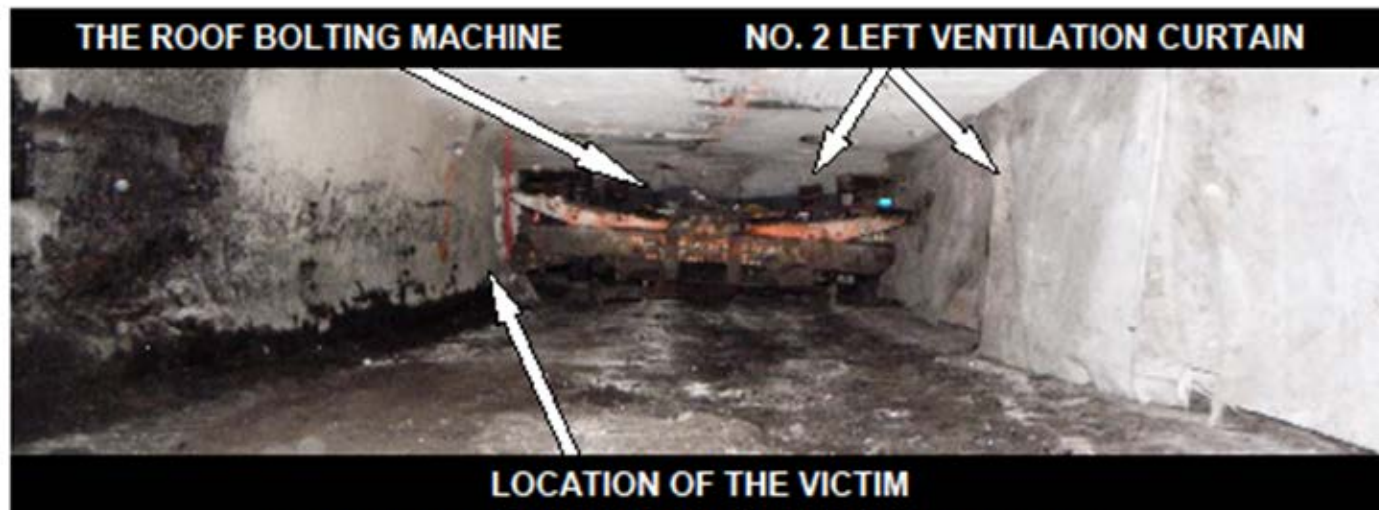
THE ACCIDENT SCENE NO. 2 ENTRY

Kentucky OMSI Serious-Non Fatal Accident No. 1– Struckby/Machinery

The accident occurred while the victim was walking between the coal rib and the ATRS of the roof bolter. The victim was accessing the work station for the installation of a row of roof supports. The supports (board row) were to be used during the installation of a run through curtain (fly pad). The victim was pinned between the ATRS and the coal rib (pillar) when the operator began to reposition the machine towards the middle of the entry.

1. Employees shall be positioned in an area that will afford them maximum protection.
2. The equipment operator shall be aware of the position of fellow miners prior to moving equipment.
3. Miners shall be trained to recognize potential red zone hazards.

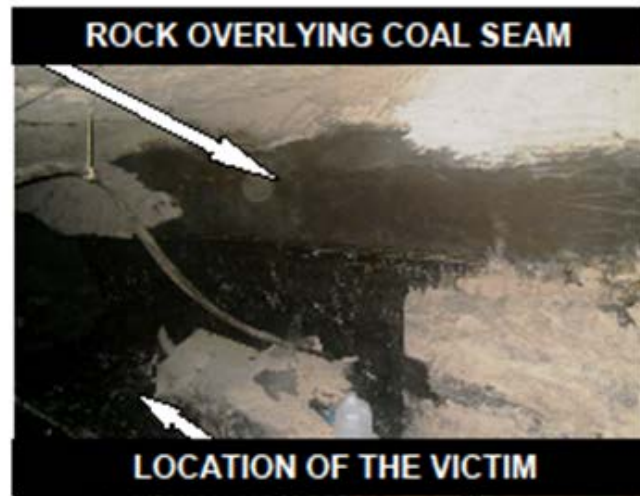
THE ACCIDENT SCENE NO. 4 ENTRY

Kentucky DMS Serious-Non Fatal Accident No. 2- Fall of Roof/Rib

The accident occurred while the victim was removing rib material with a jack hammer. The victim was removing the material to correct an area of close clearance along the belt – track entry. A portion of the rib material had been removed when the rock (brow) overlying the coal seam fell and struck the victim. He was pinned between the fallen debris and the mine floor.

1. Thorough examinations shall be conducted and unsafe conditions shall be corrected prior to performing work.
2. Work performed near unsafe rib conditions shall be done from a safe location.
3. All personnel involved in removal of rib material shall be trained in the associated hazards.

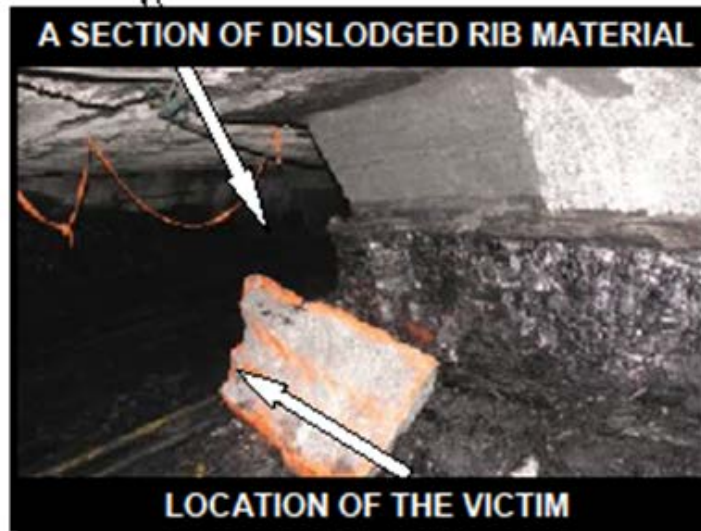
THE ACCIDENT SCENE NO. 3 ENTRY

Kentucky DMS Serious-Non Fatal Accident No. 3- Fall of Roof/Rib

The accident occurred while the victim was making needed repairs to a water supply line used by the continuous miner. The victim was kneeling next to the left coal rib in the No. 3 entry, when a section of the rib next to the mine roof dislodged and struck him. The victim was pinned between the fallen debris and the mine floor, resulting in serious injuries.

1. Employees shall be positioned in an area that will afford them maximum protection.
2. Loose ribs shall be taken down or adequately supported.
3. Thorough examinations of the roof and ribs shall be conducted and unsafe conditions corrected prior to performing work.
