United States Department of Labor
**Mine Safety and Health
Administration**

Coal Mine Safety and Health

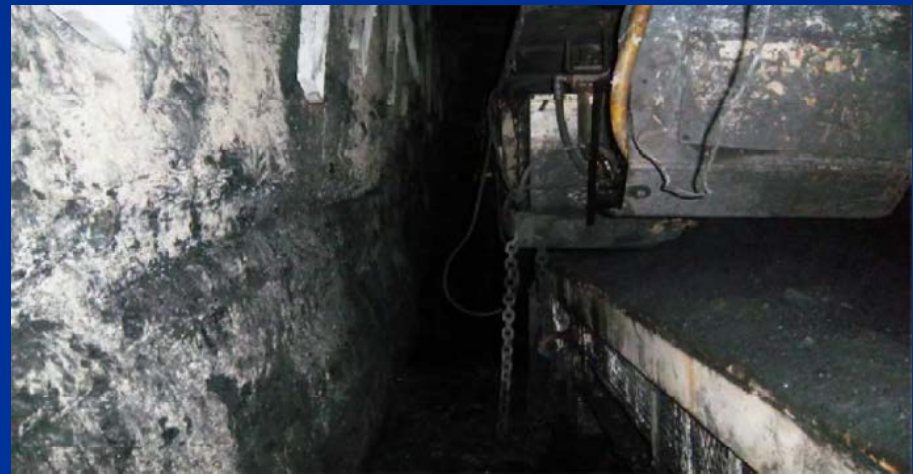
■ Coal Fatality #1 – January 16, 2014

Mettiki Coal WV, LLC
Mountain View Mine
Powered Haulage

On Friday, January 16, 2014, a 20-year-old general inside laborer with 2 years of mining experience was killed when he was struck by a feeder. The victim was standing between the coal rib and the feeder when the securing post dislodged, allowing the tailpiece unit to shift and pin him between the rib and the frame of the feeder. The victim had just finished connecting a chain between the feeder and the tailpiece when the accident occurred.

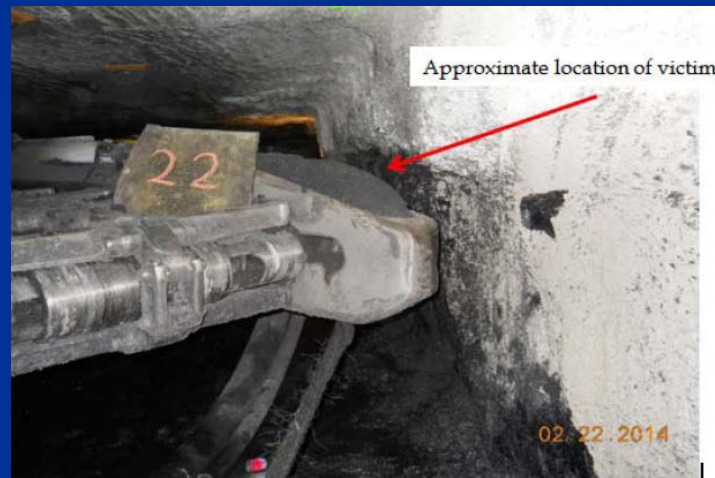
■ Coal Fatality #2 – February 21, 2014

Sun Coke Energy
Dominion #30
Machinery

On Friday, February 21, 2014, a 24-year-old continuous mining machine operator with 5½ years of mining experience was killed when he was pinned between the end of the boom of a continuous mining machine and the right coal rib. The miner was tramming the remote controlled continuous mining machine in the last open crosscut toward the Number 1 entry.

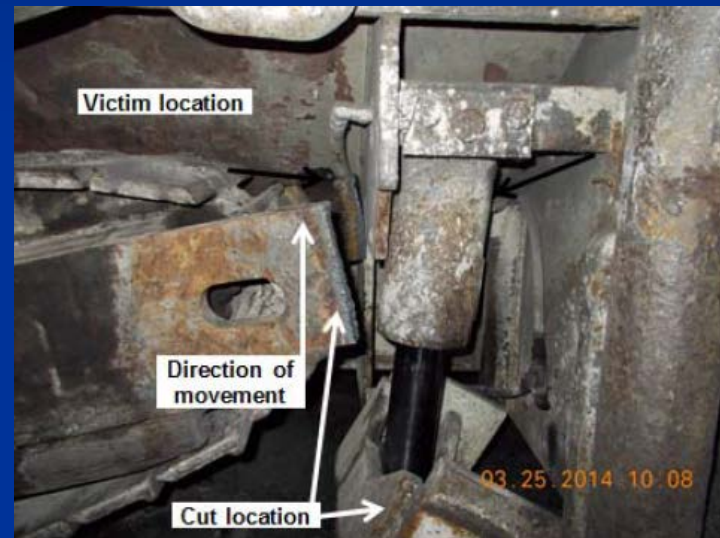
■ Coal Fatality #3 – March 25, 2014

Gibson County Coal, LLC
Gibson Mine
Machinery

On Tuesday, March 25, 2014, at approximately 1:45 a.m., a 41-year-old mechanic trainee with 23 weeks of mining experience was killed while working on a belt feeder. The victim was cutting through the inner left side plate of the crawler assembly that connects the hopper jack assemblies to the crawler frame. When the cut was completed, the crawler assembly pivoted upward, pinning the victim between the crawler track and the frame of the feeder.

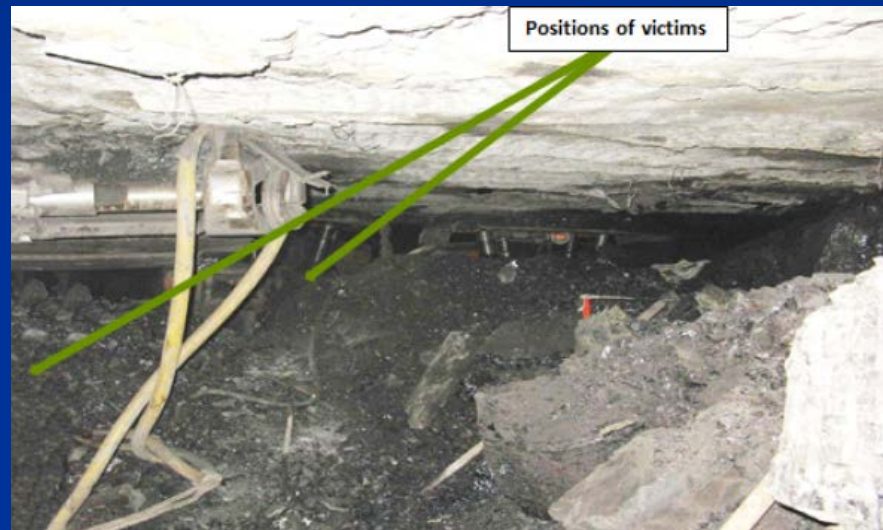
■ Coal Fatality #4 and #5 – May 12, 2014

Brody Mining, LLC
Brody Mine No. 1
Fall of Face/Rib/Highwall

On Monday, May 12, 2014, a 48-year-old continuous mining machine operator with 26 years of mining experience, and a 46-year-old mobile roof support operator/roof bolter with 3½ years of mining experience, were fatally injured as a result of a coal rib burst. The section crew was retreat mining in the #6 entry of the 4 East Mains Panel. They were mining the second lift of the left pillar block when the accident occurred.

During the past two years, three serious coal bursts have occurred at deep cover retreat mines. The events at Panther No. 1, Huff Creek No. 1, and Brody Mine No. 1 have resulted in three fatalities and two permanently disabling injuries. In all three cases the pillars were properly sized and met all the NIOSH pillar stability factor criteria. In addition, none of these three mines had ever reported a burst before.

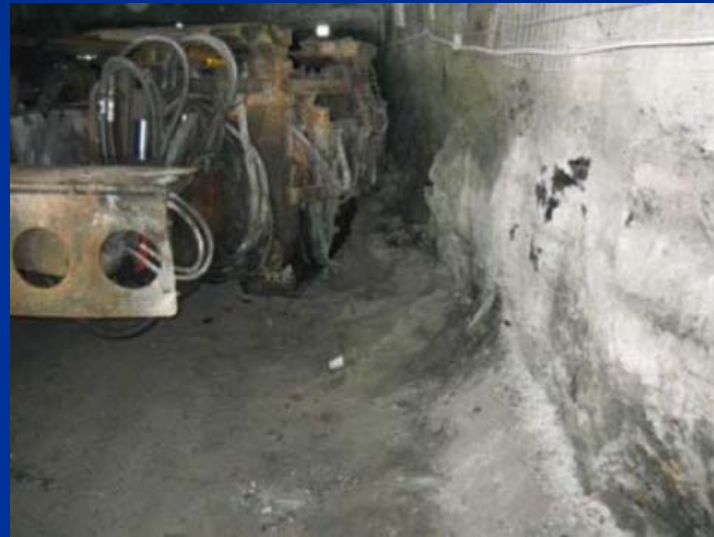
■ Coal Fatality #6 – May 14, 2014

M Class Mining
MC #1 Mine
Machinery

On Wednesday, May 14, 2014, a 25-year-old roof bolter operator with 1 year and 44 weeks mining experience was killed when he was pinned between a roof-bolting machine and the coal rib. The victim and another roof bolter operator were in the process of tramming the roof-bolting machine in the outby direction in the No. 3 entry on the No. 1 Longwall Tailgate. They had trammed the roof bolting machine from the 151 crosscut to approximately the 89 ½ crosscut when the accident occurred. The victim was found on the left side of the roof-bolting machine between the machine and the coal rib.

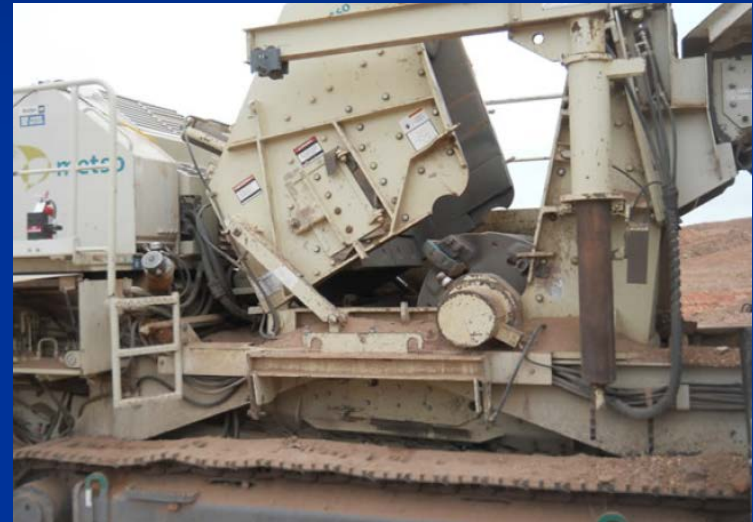
■ Coal Fatality #7 – June 4, 2014

Peabody Powder River Mining, LLC
North Antelope Rochelle Mine
Machinery

On Wednesday, June 4, 2014, a 25-year-old contract equipment operator with 24 weeks of experience was killed when he was crushed between the hood and frame of an impact crusher. The victim had just finished clearing a large rock from the crusher area when the accident occurred.

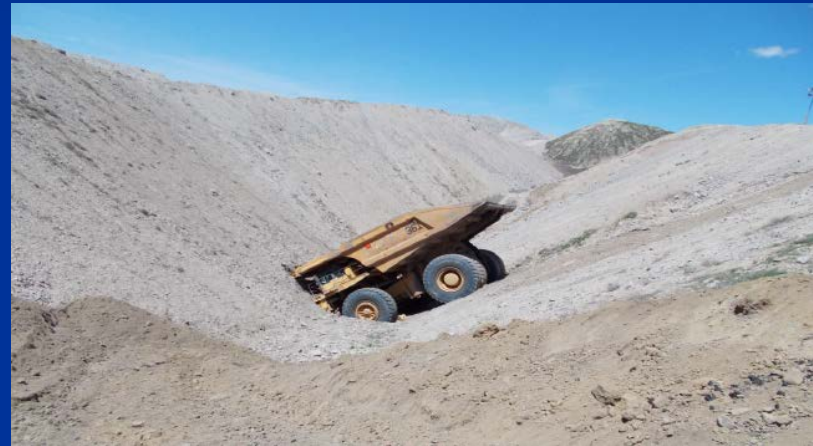
■ Coal Fatality #8 – June 23, 2014

Cloud Peak Energy
Spring Creek Mine
Powered Haulage

On Monday, June 23, 2014, at approximately 7:35 p.m., a 58-year-old truck driver, with 5 years of mining experience, was killed when the haul truck he was operating traveled through a berm and descended approximately 75 feet into a spoil “V.”

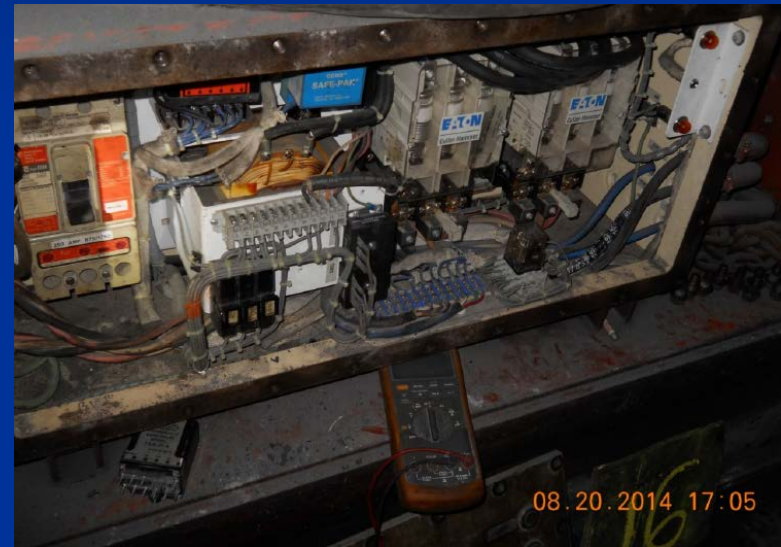
■ Coal Fatality #9 – August 20, 2014

CONSOL Buchanan Mining
Company, LLC
Buchanan Mine #1
Electrical

On Wednesday, August 20, 2014, a 41-year-old maintenance supervisor with approximately 19 years of mining experience was killed when he came in contact with an energized component inside an explosion proof enclosure. The victim had removed the enclosure's panel cover and was troubleshooting or performing electrical work on the 600 VAC roof bolting machine when he was electrocuted.

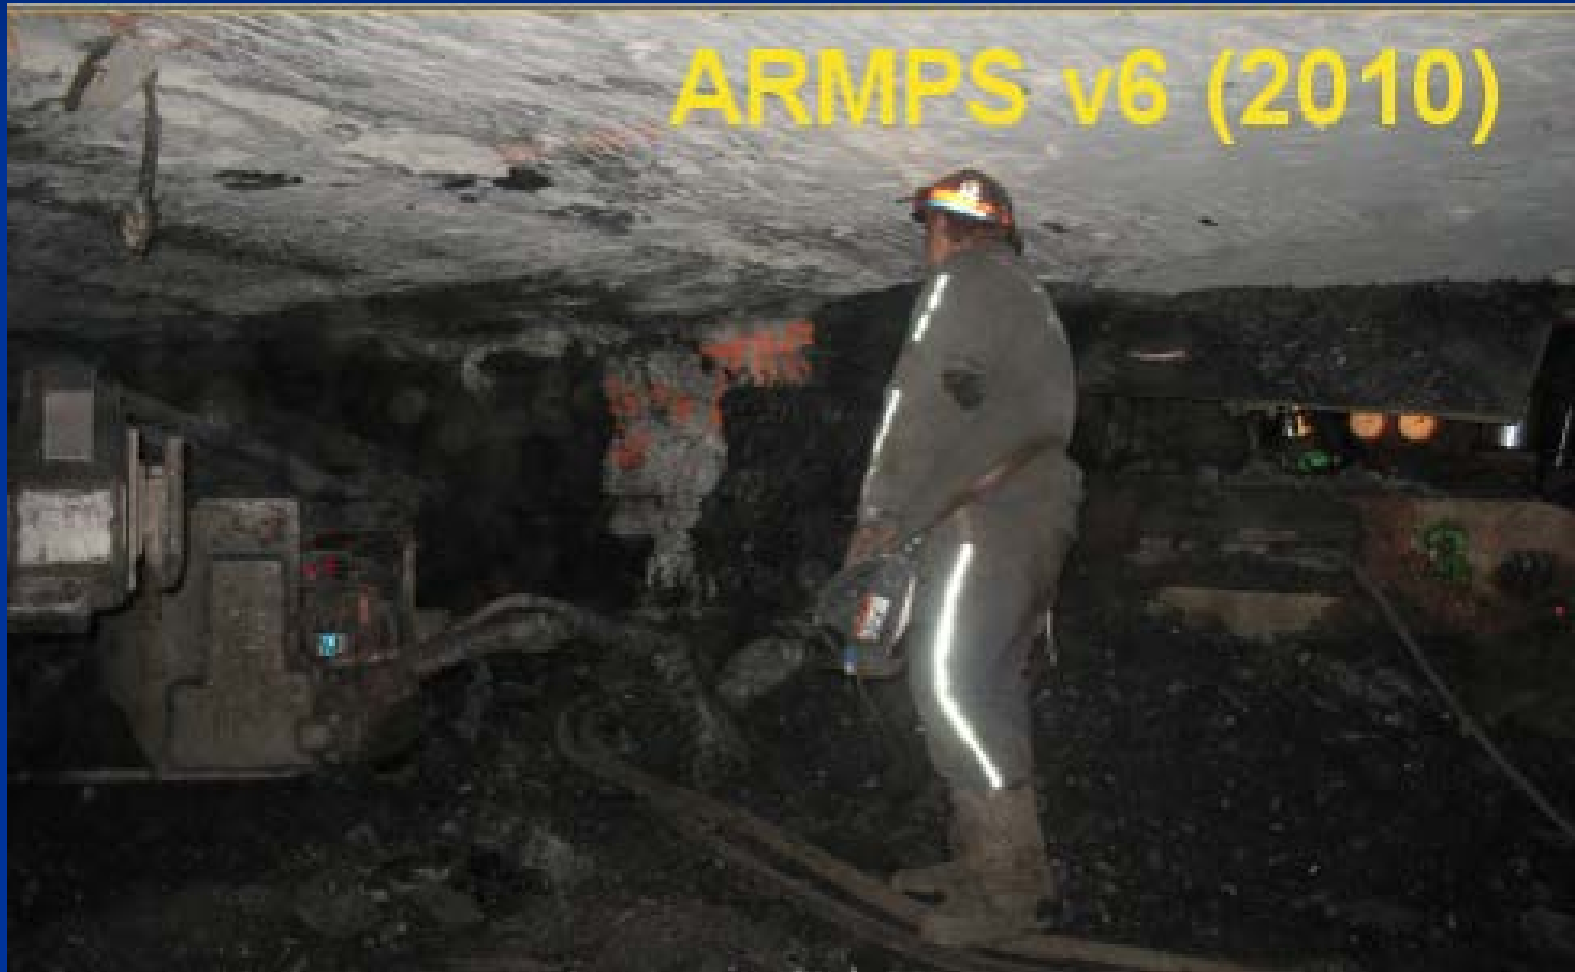
ARMPS SF
(Production Pillars)

Analysis of Retreat Mining Pillar Stability (ARMPS): Version 6 (2010)

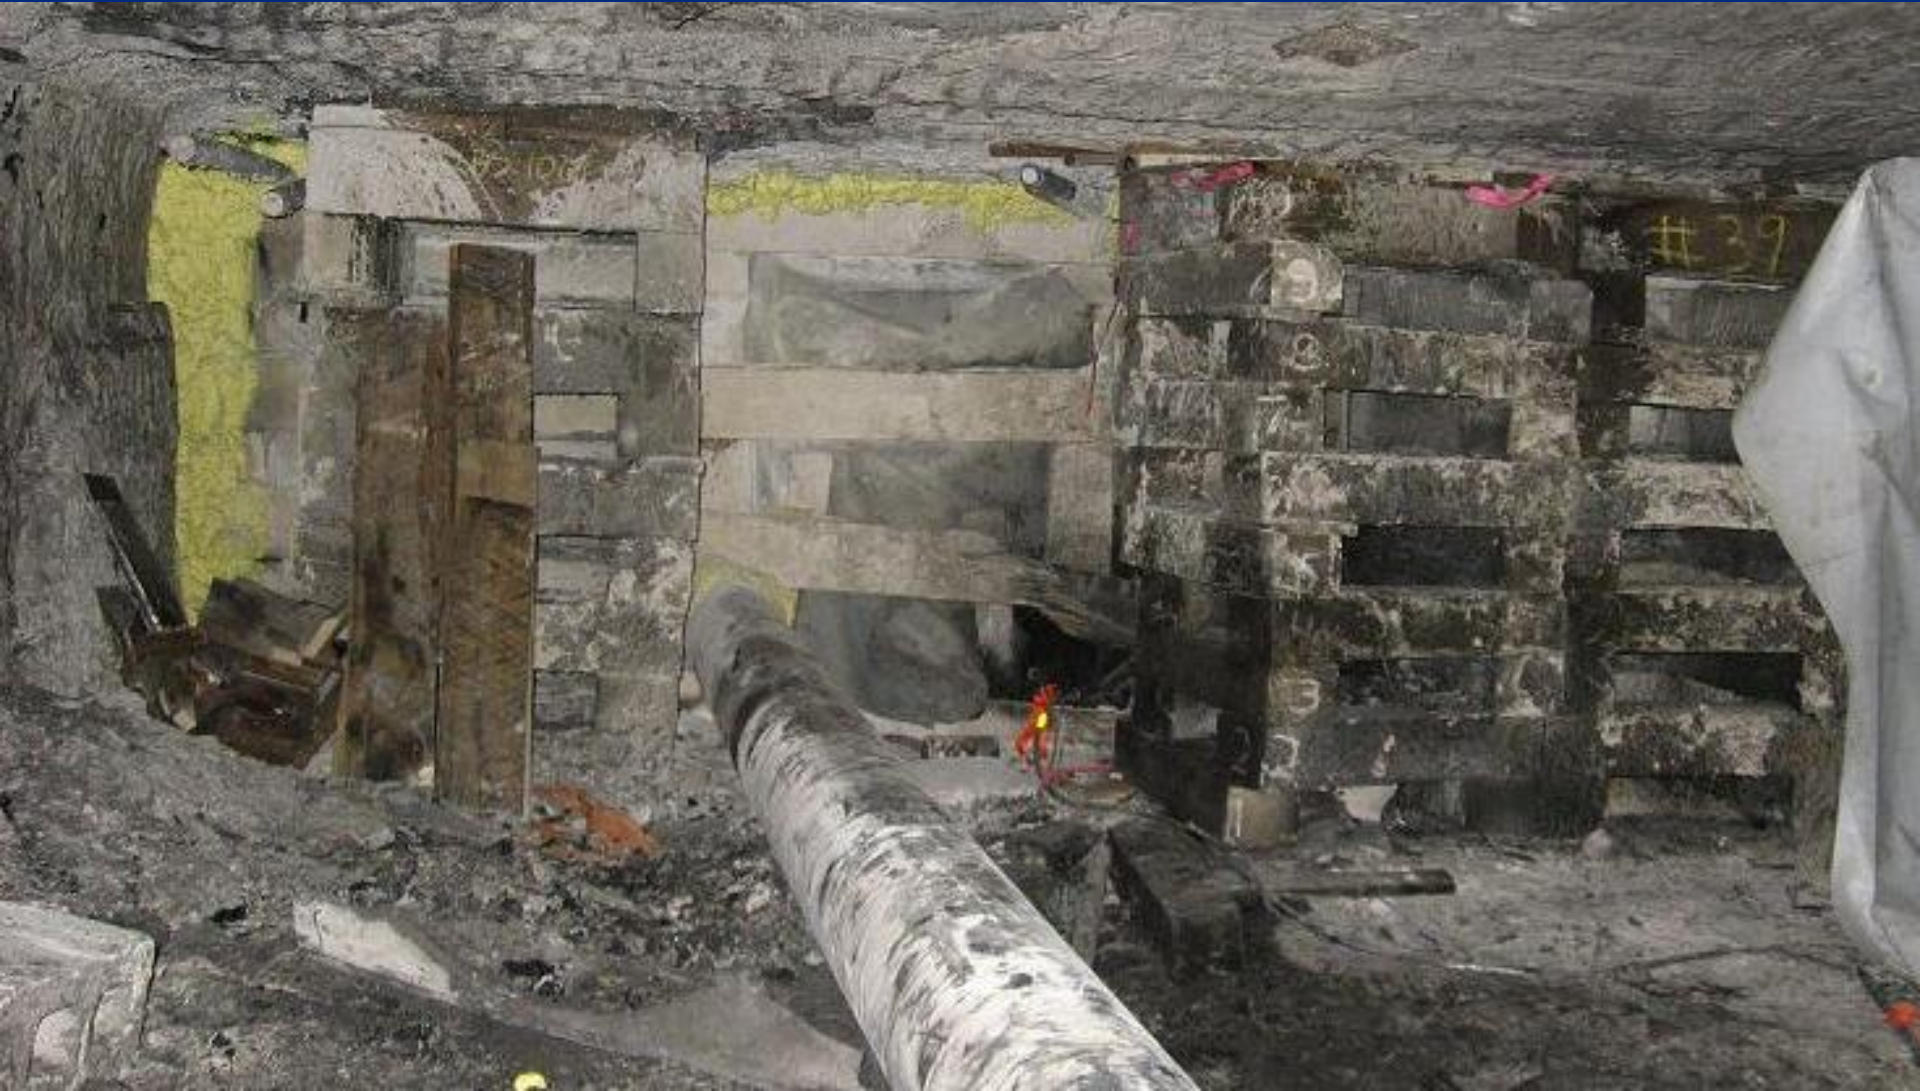
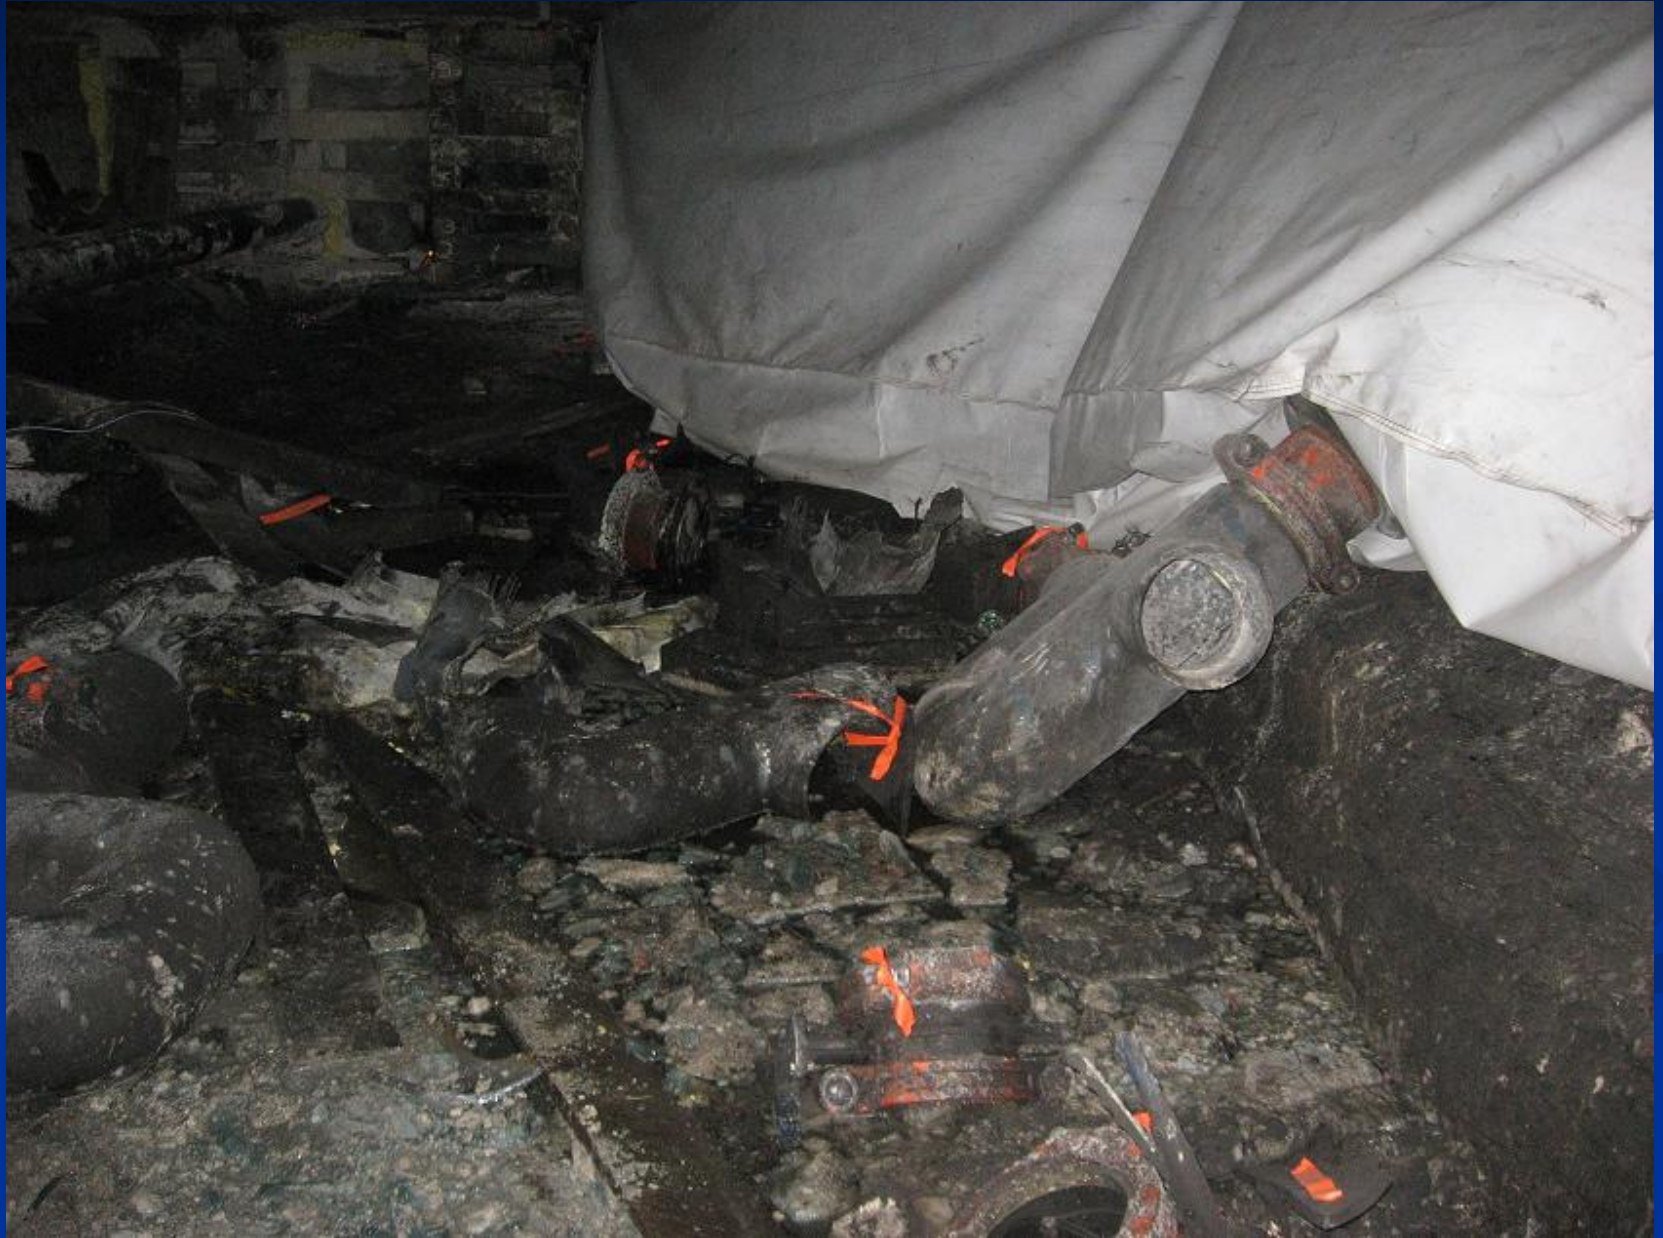
Pleasant Hill Mine

An explosion occurred within a sealed area of an underground coal mine on June 30, 2012. The 120-psi seals exhibited no apparent signs of structural damage. However, the forces from the explosion severely damaged 3 of the 4 PVC water drainage pipes installed through the lowest seal in the set. Testing and independent evaluations led to the conclusion that the Schedule 80 PVC pipes failed due to a rapid internal over-pressurization. The only pipe remaining intact did so because the water trap assembly was not secured to the pipe. Pressure relief was provided when the forces dislodged the trap from the end of the pipe.

- Water Drainage Systems were Damaged
